UNITED STATES ENVIRONMENTAL PROTECTION AGENCY

Re: Warning Letter and Certification of Violation Correction for National Steel and Shipbuilding Company

John Martin  
Environmental Engineering Specialist  
National Steel and Shipbuilding Company  
P.O. Box 85278  
San Diego, CA 92186-5278  
EPA Identification Number: CAD009158932

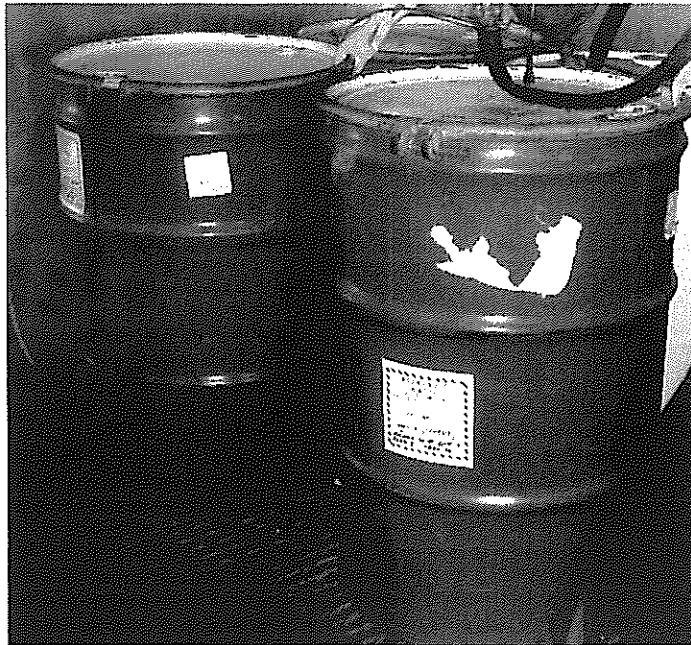
**Photo 2: Machine Shop SAA #1**

– **Machine Shop Satellite Accumulation Area #2**

There were four 55-gallon containers in this area, two containing non-RCRA hazardous waste and one containing “excluded recyclable materials.” The fourth drum (“empty containers”) did not contain hazardous waste. No violations were noted in this area.

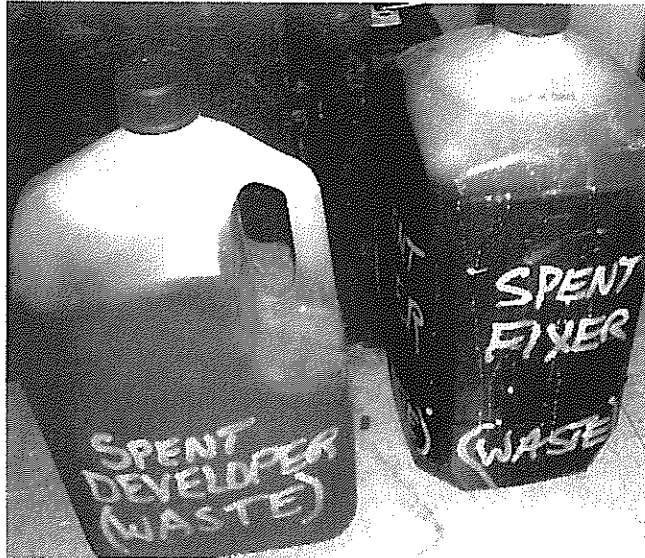
**Photo 6: Inadequately labeled containers in NDT Building**

There were a one-gallon container identified as “spent fixer” and a one-gallon container identified as “spent developer.” Neither container conformed to the regulatory requirements for hazardous waste labeling as described under CCR Title 22 §66262.34(e)(1)(E), specifically lacking:

- the words “Hazardous Waste”;
- an accumulation start date;
- the composition and physical state of the waste;
- the hazardous properties of the waste;
- the name and address of the person producing the waste.

This has been addressed post-inspection in NASSCO’s Environmental Corrective Action Request #EC-2005-038 (Attachment 1).

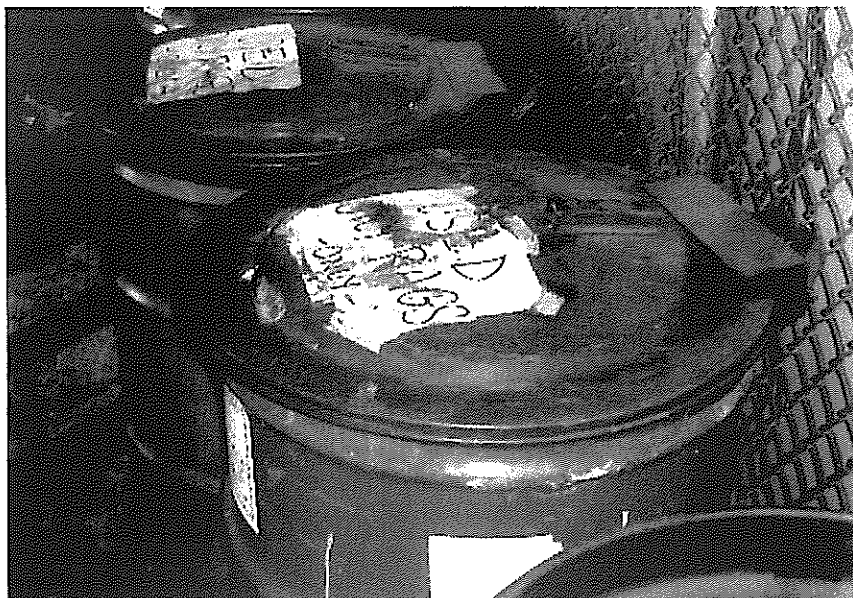
**Photo 18: Pipe shop rag and glove 55-gallon drums**

The inspectors noted contaminated cotton gloves in the oily rag bins, even though, per the facility representatives, contaminated cotton gloves are discarded, not laundered and recycled. The inspectors requested that concerned facility personnel be better trained in proper disposal of the contaminated cotton gloves, i.e., they are not to be considered "excluded recyclable material."

These potential violations have since been addressed with documentation per NASSCO's email to EPA dated 12-22-05 (Attachment 1)

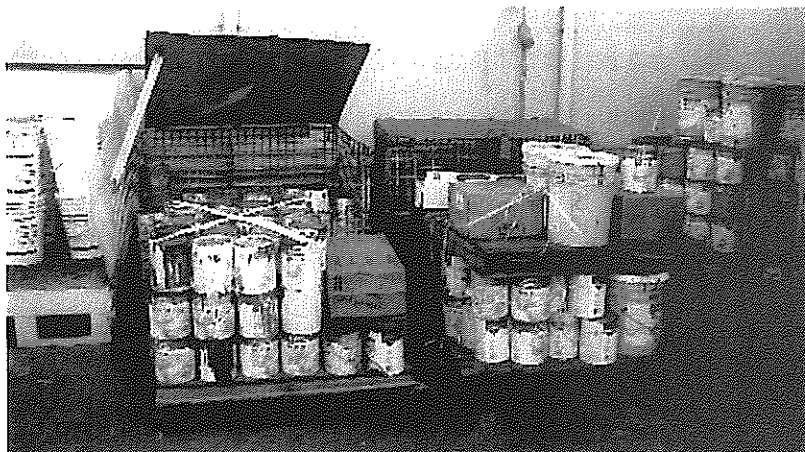
**Photo 19: Pallets of paint awaiting further use near solvent still**

Adjacent to the still, in the same yard, were multiple pallets of partially full paint cans, some marked with paint expiration dates, others not. Per the facility representative, the cans stored here represent product available for further use. In one instance, one 1-gallon can of solvent based paint had an expiration date of August, 2005.

The inspectors requested that an inventory be performed on the paint stored in this area, and if other containers of paint were found with expiration dates that have since passed, that these containers be properly disposed of. Per the facility's Work Instruction #103, dated November 29, 2005 (Attachment 1), this inventory was performed and paint-related hazardous wastes were manifested offsite for disposal on December 1, 2005.
